VEHICULAR CRASH TESTS OF  
A NESTED THREE BEAM TRANSITION BARRIER  
FINAL REPORT # FHWA/CA/TL-2001/09

STATE OF CALIFORNIA  
**DEPARTMENT OF TRANSPORTATION**  
ENGINEERING SERVICES  
MATERIALS ENGINEERING AND TESTING SERVICES

CALTRANS STUDY # 680837

1. REPORT NO. FHWA/CA/TL-2001/09	2. GOVERNMENT ACCESSION NO.	3. RECIPIENT'S CATALOG NO.	
4. TITLE AND SUBTITLE Compliance Crash Testing of a Nested Thrie Beam Transition Barrier		5. REPORT DATE May 2002

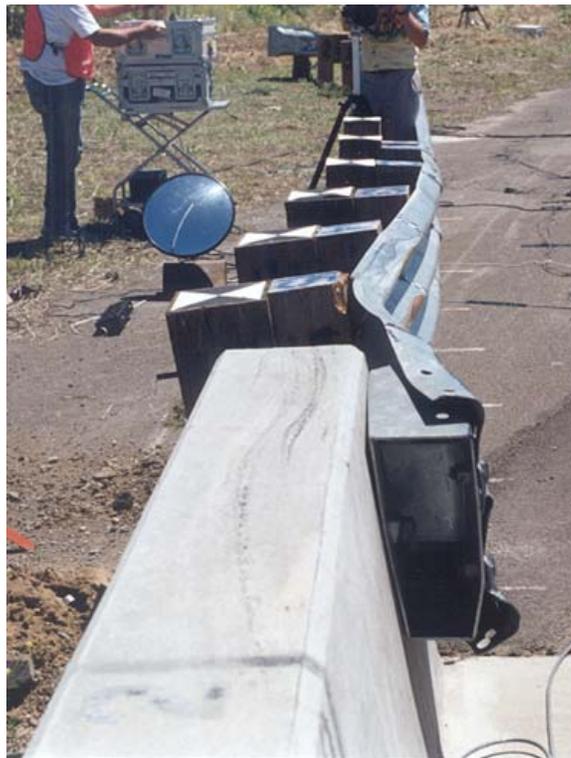
Figure 2-6 - Test 516 Barrier Damage

Damage to the barrier consisted of a pocketed thrie beam section, posts that had been pushed back, and a deformed metal box spacer. The maximum, permanent post deflection was 270 mm which occurred at post 15. Posts 13 and 14 also move significantly with 90 and 180 mm of deflection, respectively.

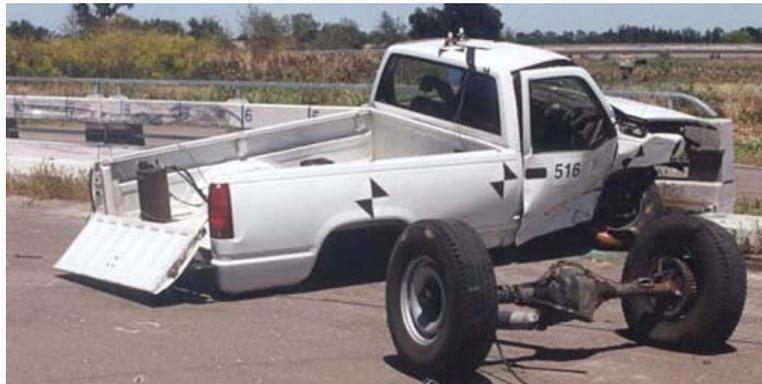
Figure 2-7 Test 516 - Post Impact Vehicle Damage

Damage to the vehicle was extensive. The right side of the engine compartment was pushed back into the firewall. The right front tire was pushed back and under the doorjamb. The right door was crumpled and jammed. The rear axle was completely separated from the frame. The drive shaft had severed near the transmission. The windshield was severely cracked, but not penetrated. The maximum floor deformation on the passenger side was 210 mm.

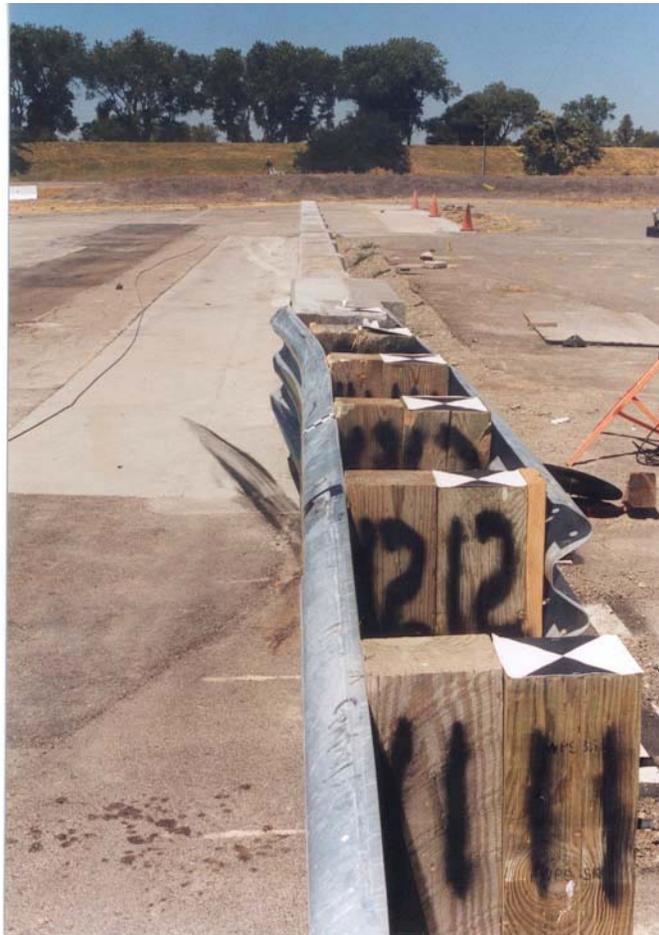
Figure 2-13 - Test 517 Barrier Damage

The barrier damage consisted of two bent thrie beam members and some posts that needed to be straightened. The greatest dynamic deflection was at Post 14 with a lateral deflection of 180 mm. The maximum permanent deflection was 95 mm at post 13.

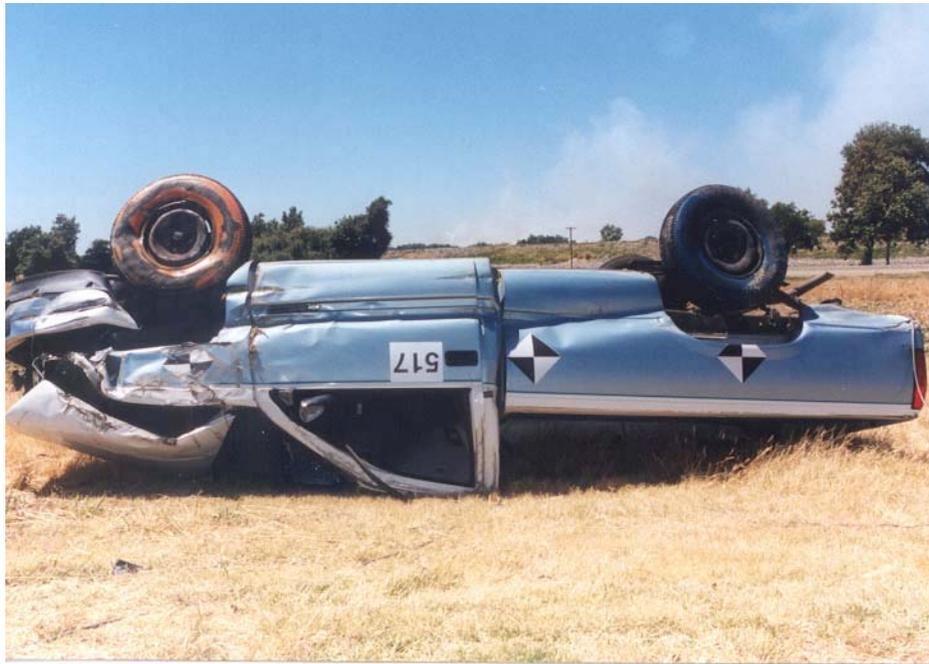
Figure 2-14 - Test 517 vehicle Damage

Damage to the vehicle was extensive. The right front corner of the vehicle sustained some damage prior to the rollover. The right third of the bumper was pushed back into the tire. The hood was crumpled. A crease from the thrie beam extended along the entire right side of the vehicle.

The remainder of the damage was due to the rolling of the vehicle, which included the crushing of the cab and the hood.

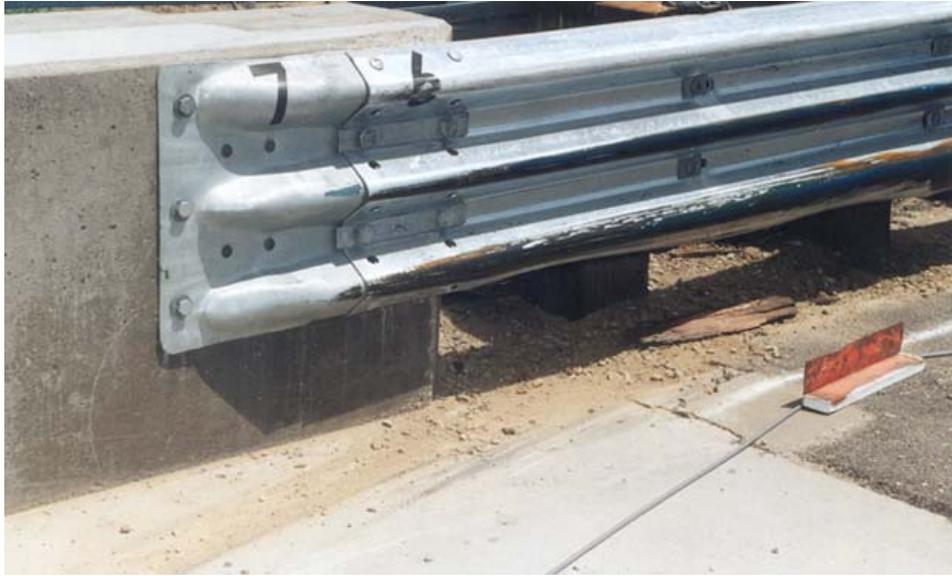
Figure 2-19 - Test 519 Barrier Damage

The barrier received minimal damage during impact. The posts exhibited small amounts of permanent lateral deflection. For posts 12, 13, 14, and 15 the deflections were 10, 19, 25, and 13 mm at the tops, respectively. The blockout for post 14 was damaged enough to require replacement. There was minor scraping and scuffing of the barrier.

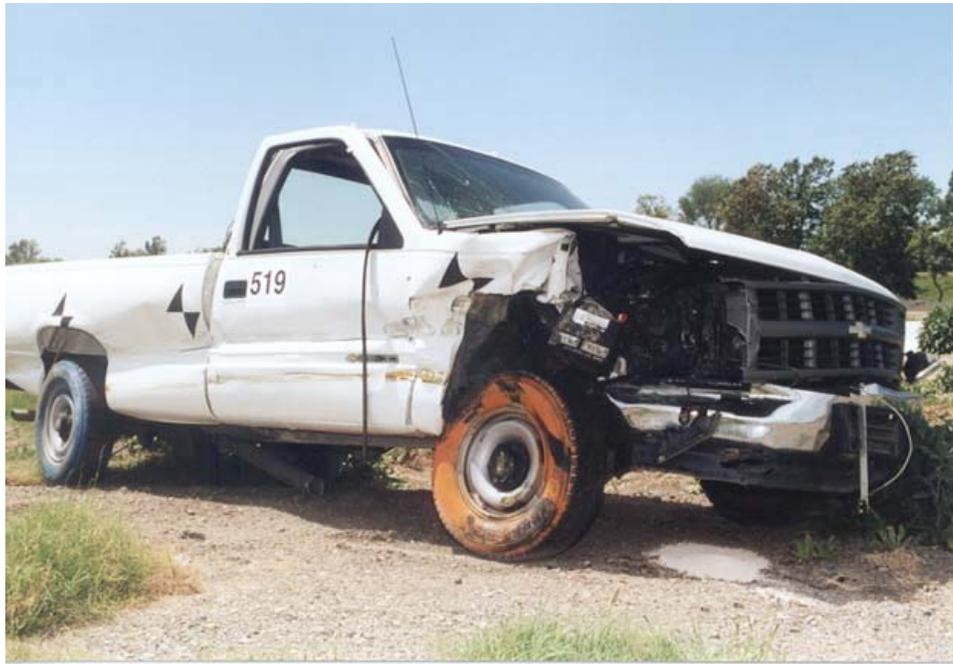
Figure 2-20 - Test 519 Vehicle Damage

Most of the vehicle damage was limited to the front and right side. The right front corner was pushed in, exposing the battery and crumpling the corner panel. The steering linkage was still connected, but no longer functional. The front right wheel was pushed back and pressed up against the firewall. The right third of the bumper was pushed back into the vehicle. The right side of the vehicle was creased where contact had been made with the barrier rail.

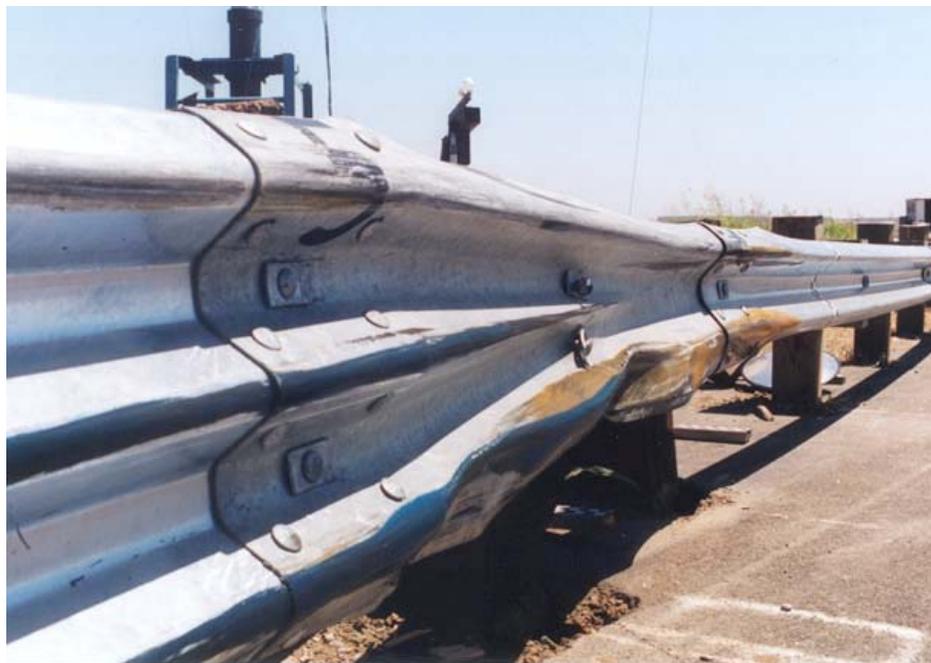
Figure 2-25 - Test 518 Barrier Damage

The barrier received minimal damage during impact. The posts had moderate permanent lateral deflection. Posts 9, 10, 11, 13, 14, and 15 deflected 52, 164, 162, 80, 41, and 65 mm at the tops, respectively (post 12 also deflected, but the measuring target was destroyed during impact). The blockout for post 11 was damaged enough to require replacement. The Y-section and the 10-ga. W-beam section needed to be replaced. Several of the posts needed to be straightened, but were still useable.

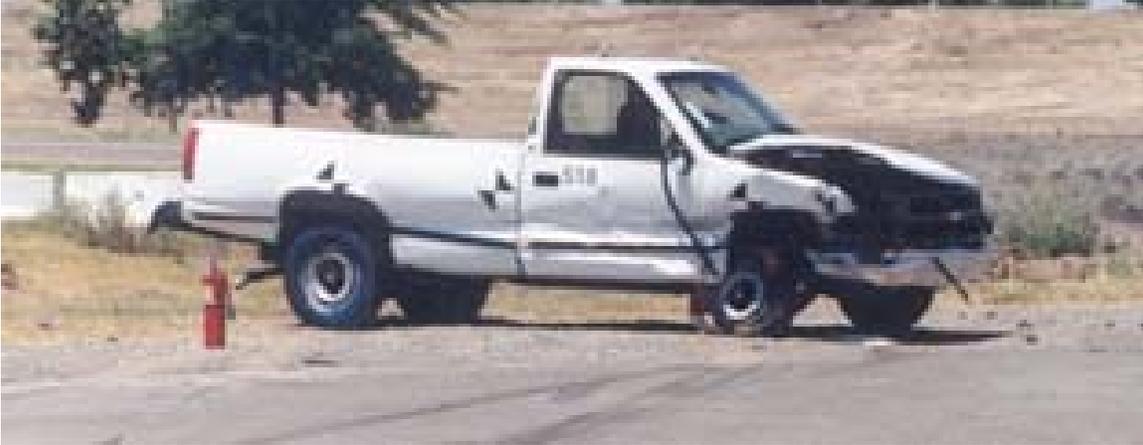
Figure 2-26 - Test 518 Vehicle Damage

Most of the vehicle damage was limited to the front and right side. The right front corner was pushed in, exposing the battery and crumpling the corner panel. The steering linkage was no longer functional. The front right wheel was pushed back and pressed up against the firewall. The right third of the bumper was pushed back into the vehicle and the right side of the vehicle was creased where contact had been made with the barrier rail.

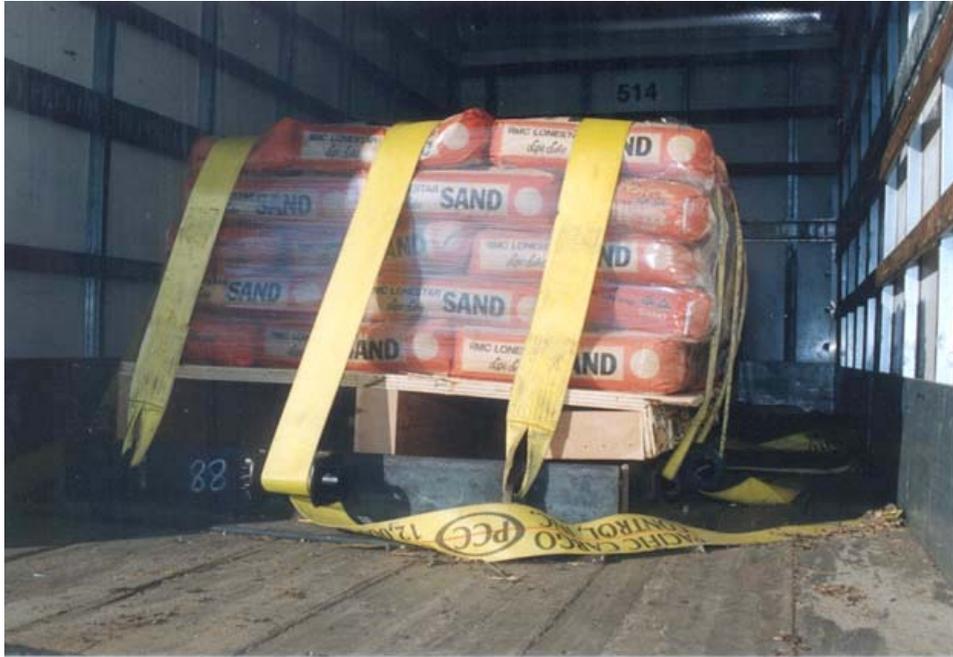
Figure 2-28 - Test 514 Cargo Shift

The cargo box shifted to the right during impact, but was not penetrated. The ballast also shifted to the right.
